Navajo Abandoned Uranium Mine

Site Screen Report

Mesa III, Northwest Mine AUM Site

Navajo AUM Northern Region

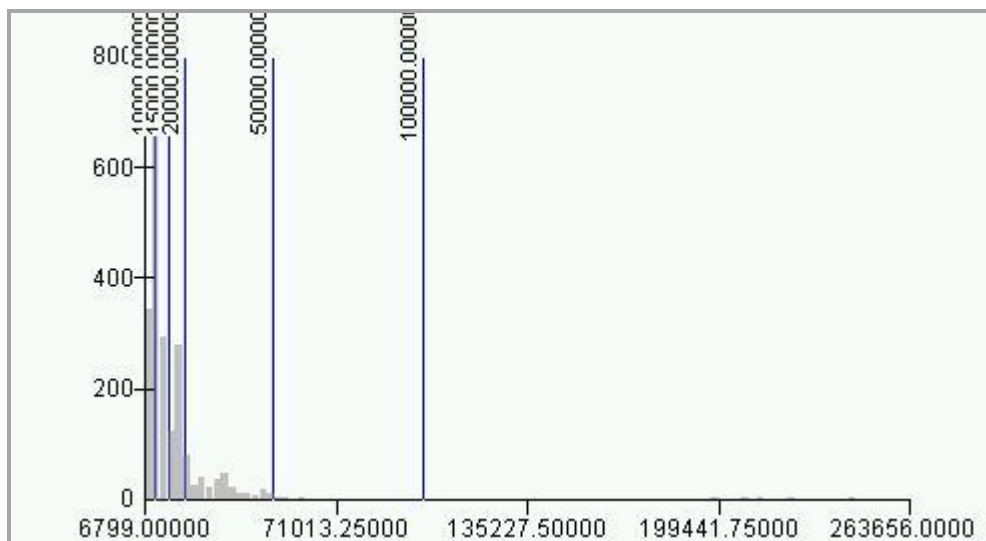
The following chart and statistics were generated by ESRI ArcGIS 9.3.1, and show the general distribution of the site gamma radiation measurements. The horizontal X axis represents the gamma radiation reading levels in cpm (lowest levels to the left). The vertical Y axis represents the frequency of each gamma radiation level.

Count:	2126
Minimum:	6799.00000
Maximum:	263656.00000
Sum:	38435816.00000
Mean:	18078.93509
Median:	11970.50000
Standard Deviation:	24418.33696

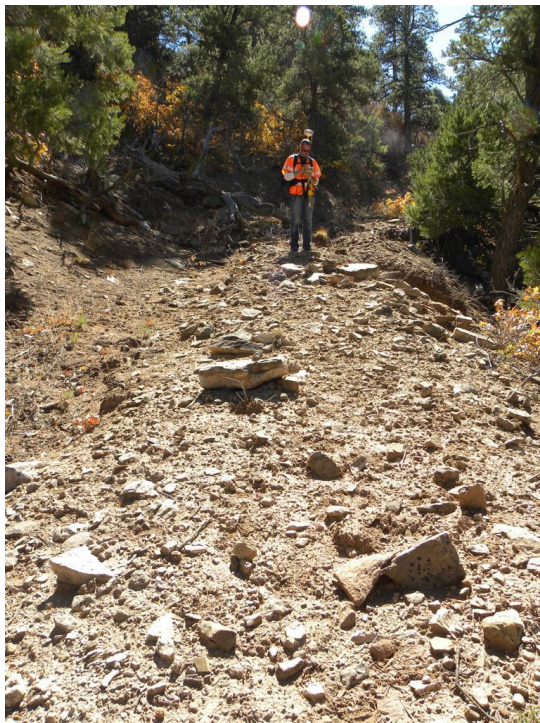
Fine waste pile, 10' x 30', with a total estimated volume of 56 yd³

Photo 1. Waste rock

Unreclaimed waste pile

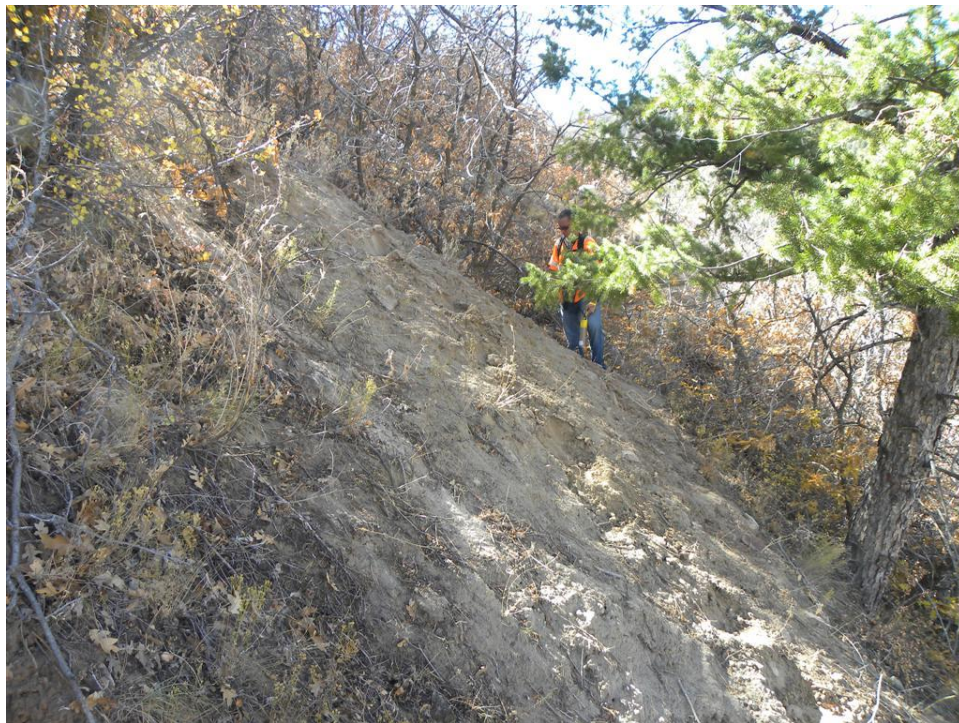
Photo 2. Mine site incline

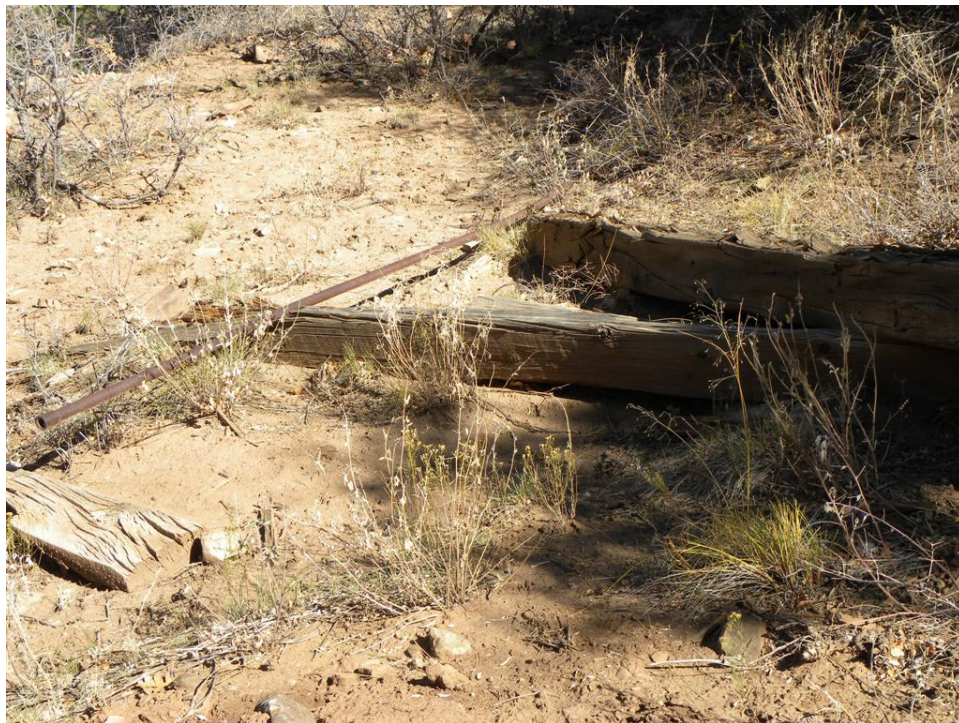
Wooden beam remnants, drainage pipe, mining debris extends through vegetation down steep decline

Photo 3. Mining debris

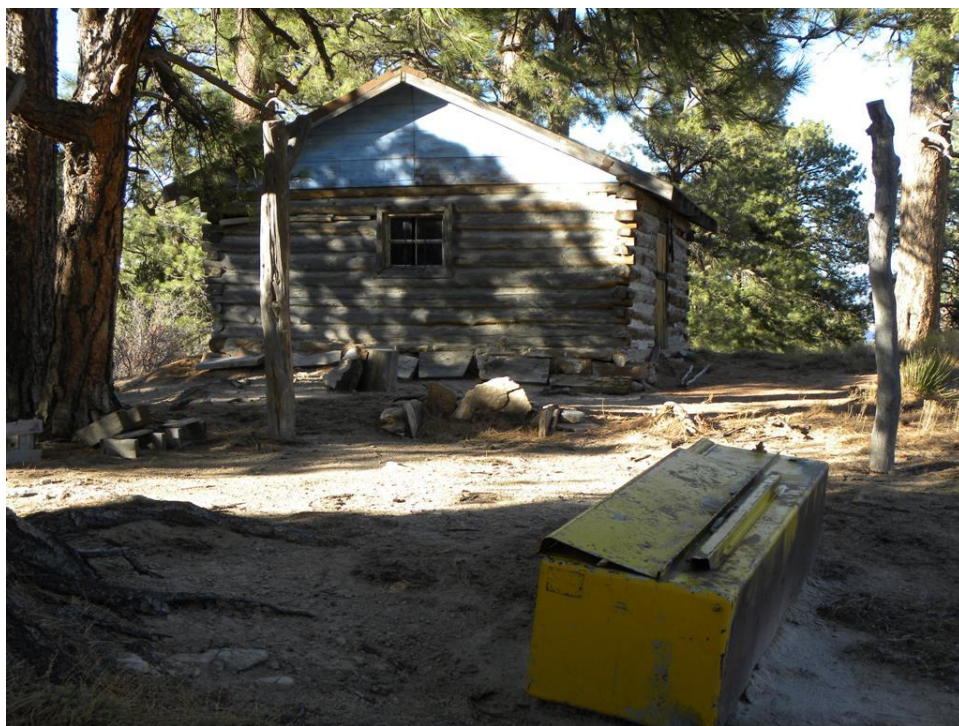
200 feet to 0.25 mile: An unoccupied house was located at the top of the mesa, approximately 0.25 miles southeast of the site.

All gamma radiation measurements collected in the vicinity of the house were less than 11,000 cpm.

Photo 4. House 0.25 miles southeast of site

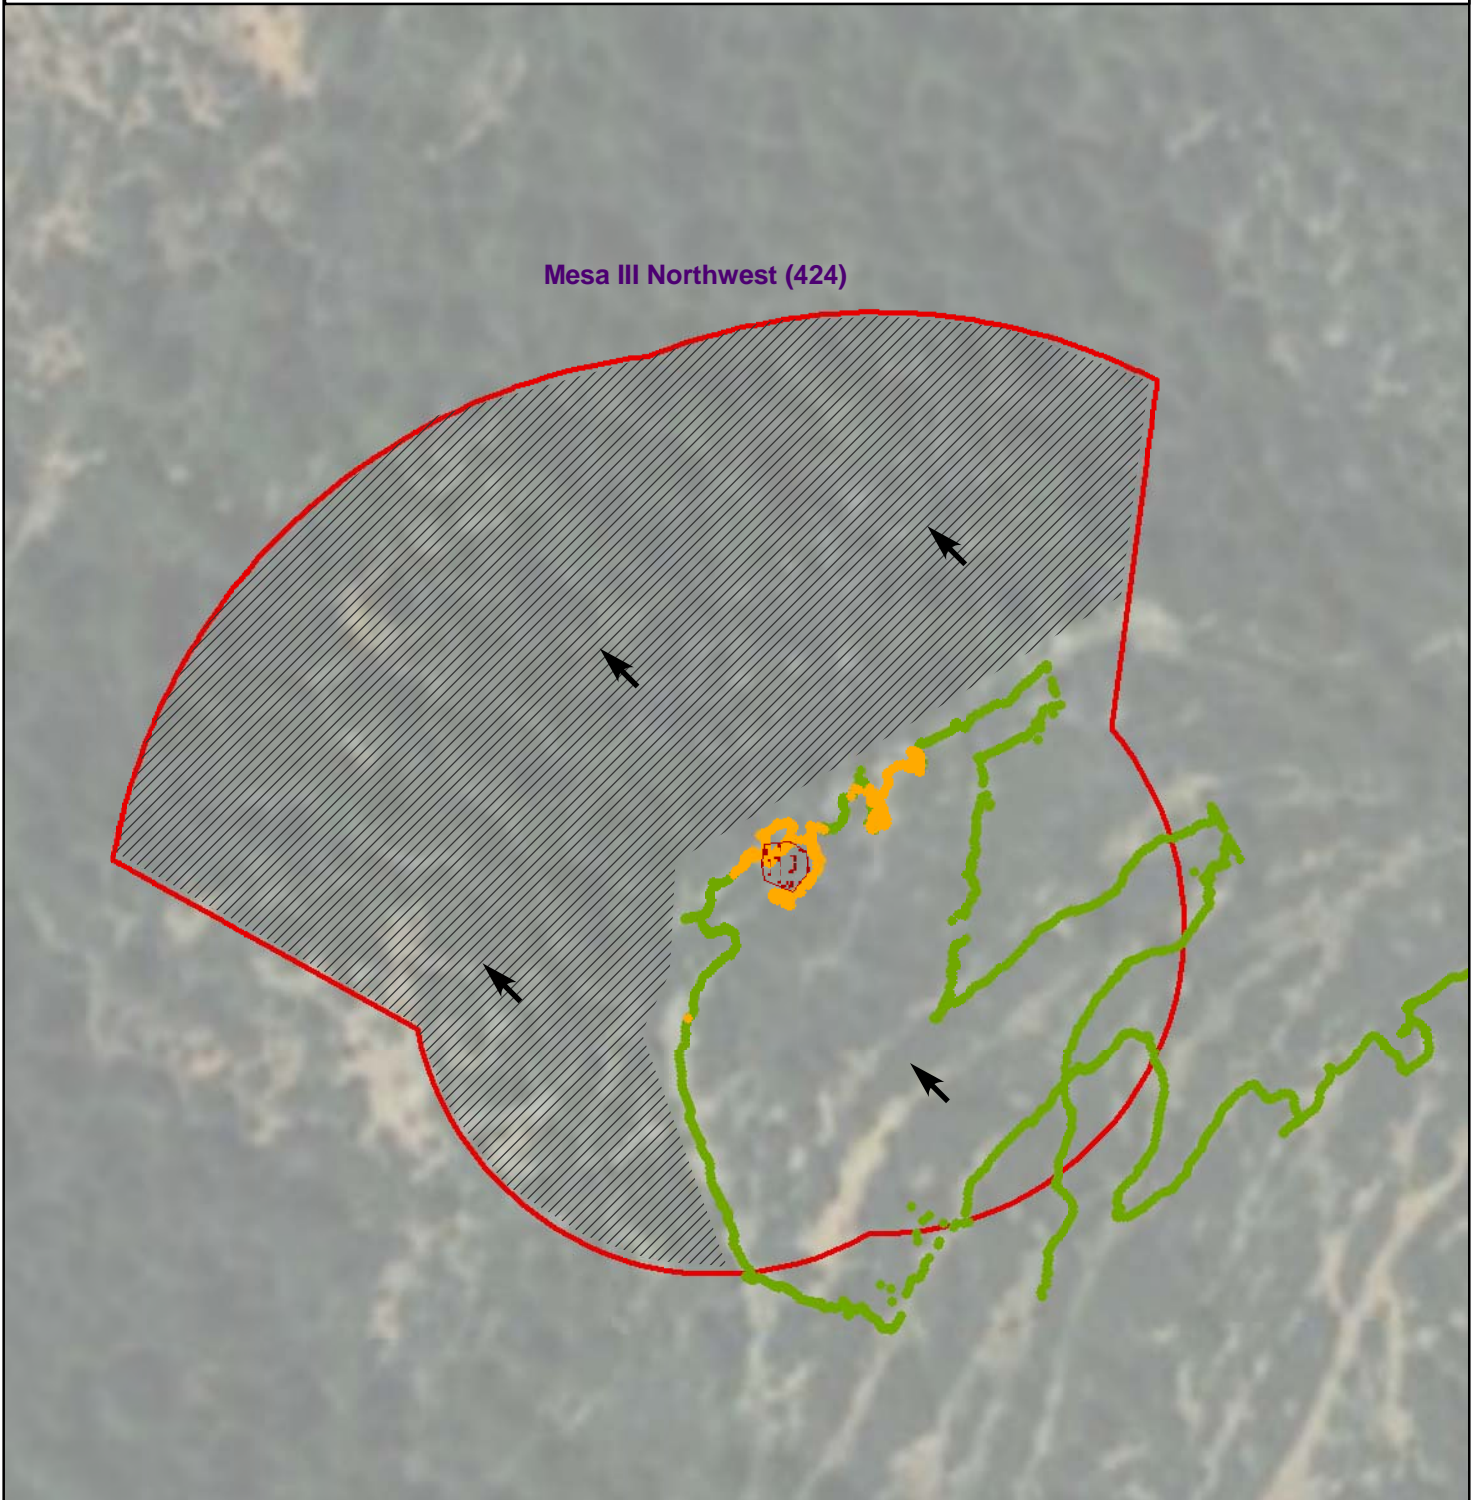
**Figure 1 - Gamma Radiation Measurements, Above Two Times Background
Mesa III Northwest (424)
Cove Chapter, Navajo Nation, Arizona**

A total of 2,126 gamma radiation measurements were collected from the mine site, ranging from 6,799 cpm to 263,656 cpm. Measurements at the top of the waste debris pile were found at levels above 200,000 cpm, and down gradient from the pile at 35,000 cpm. The measurements are represented in Figures 1 and 2.

Gamma survey conducted 10/2009
Measured as counts per minute (cpm)

Average background = 8,976 cpm

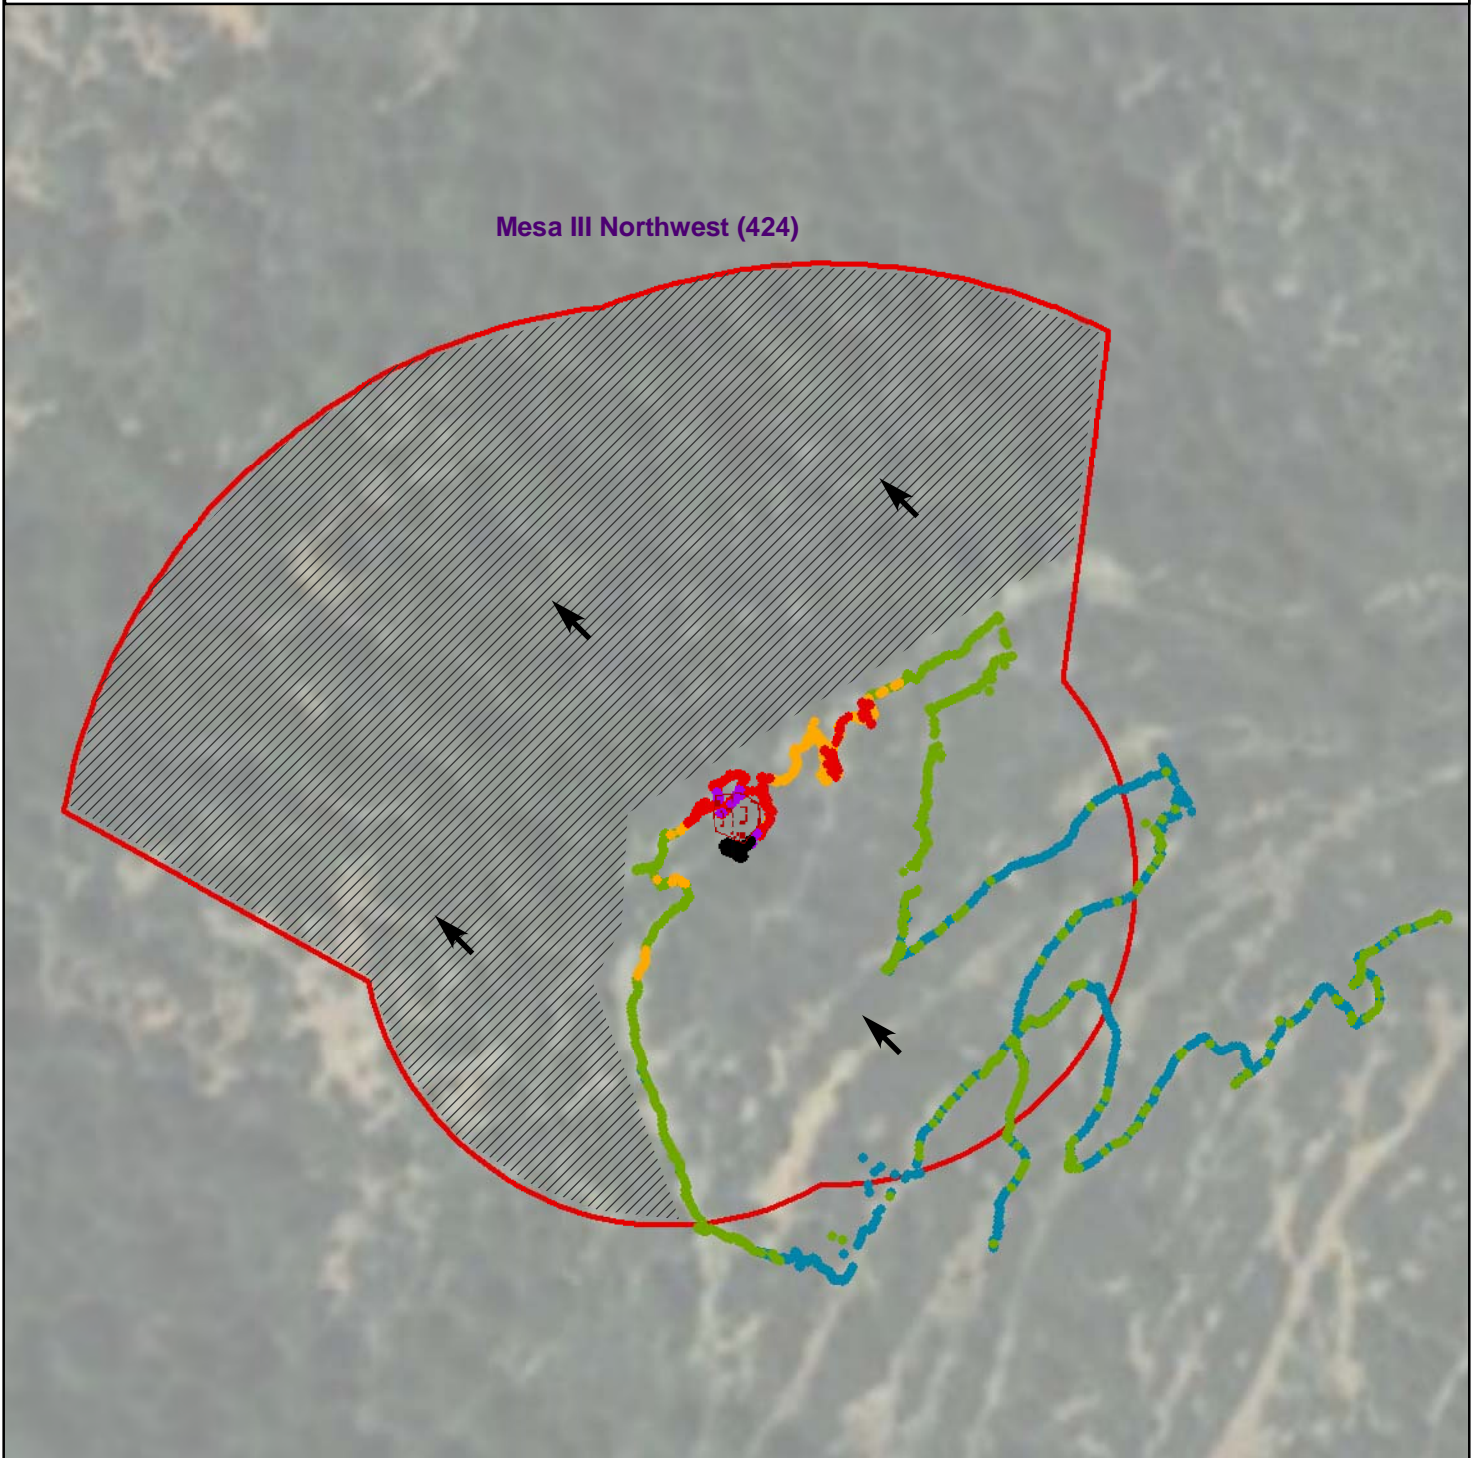
**Figure 2 - Gamma Radiation Measurements
Mesa III Northwest (424)
Cove Chapter, Navajo Nation, Arizona**

**Gamma survey conducted 10/2009
Measured as counts per minute (cpm)**

Average background = 8,976 cpm
